Impact of Flashover Fire Conditions on Exposed Energized Electrical Cords and Cables

Craig Weinschenk Daniel Madrzykowski Paul Courtney*

UL Firefighter Safety Research Institute Columbia, MD 21045

Revised October 2, 2019

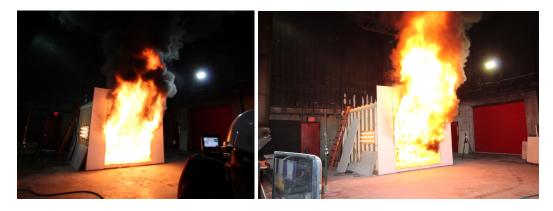
For Experiment 6, however, the distribution of fuel within the compartment (fuel around the perimeter of the room and floor to ceiling) changed due the addition of MDF paneling on the walls. This led to an increase in burning exterior to the compartment as shown in the comparison images between Experiments 5 and 6 in Figure 4.2. Figure 4.2 shows the fire external to the room in both Experiments 5 and 6 prior to any of the circuits being tripped. Outside of Experiment 1, which had a slower initial growth as the fire initially burned in depth in the seat cushion versus burning into the back cushion; fire was first visible outside of the compartment at approximately 2:45 (165 s) after ignition. As all of the fuel loads were sufficient to transition the room to flashover, external burning was a product of excess fuel and the fixed ventilation opening.

Figure 4.2: Photographs of the room during flashover, prior to any of the circuits tripping - Experiment 5 (left) and Experiment 6 (right).

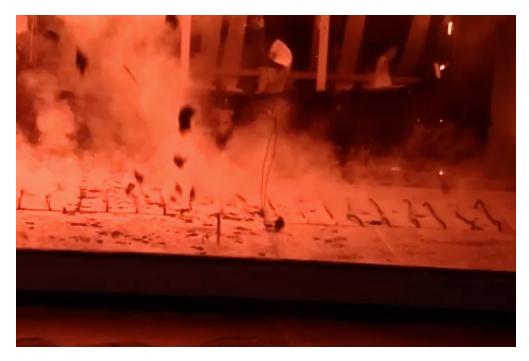
In Experiments 1, 2, and 3, however, there was debris that fell from the ceiling. The debris (Figure 4.5) landed overtop some of the heat flux gauges effectively lowering the heat flux measurement from the gauge. In Experiment 1, heat flux gauges 3 and 4 both had debris land on top of them. Figure 4.6 shows the lower values of gauges 3 and 4 through the time history of the experiment.

Figure 4.5: Experiment 1 – Debris falling from ceiling onto heat flux gauge 3.

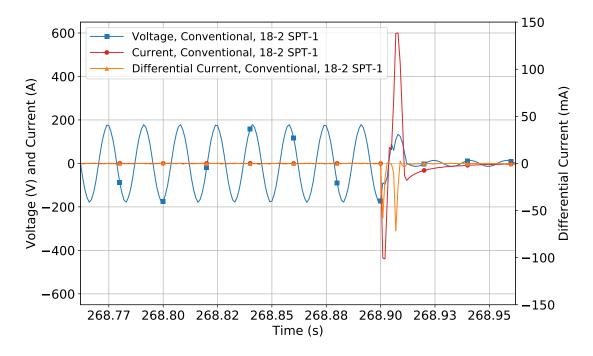
Figure 4.7: Experiment 1 – Signal data of an MCCB with 18-2 SPT1 cord (Circuit 1) that had an over-current trip.

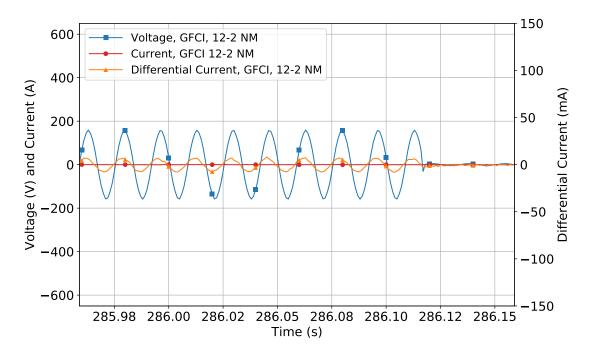
Figure 4.8: Experiment 1 – Signal data of a GFCI breaker with 12-2 NM-B cable (Circuit 9) that had a ground fault trip.

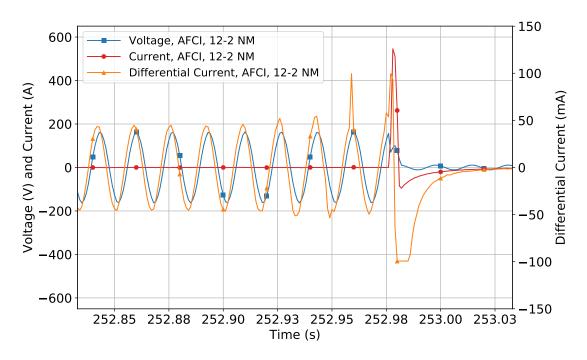
Note, not all NM-B circuits protected by AFCI breakers tripped on ground-faults. There were three examples of AFCI breakers with NM-B cable which tripped magnetically: Experiment 1-12-3 NM-B cable; Experiment 4-12-3 NM-B cable; and Experiment 5-12-2 NM-B cable. Data from these samples include high leakage currents, clipping of the differential current sensor signals, and current spikes of greater than 300 A 2 . Figure 4.9 shows that in Experiment 5, the 12-2 NM-B cable with an AFCI circuit, magnetically tripped with a current spike of 546 A. Also shown is the clipping of the differential current signal at 99.7 mA.

Figure 4.9: Experiment 5 – Signal data of a AFCI breaker with 12-2 NM-B cable (Circuit 8) that had an over-current trip.

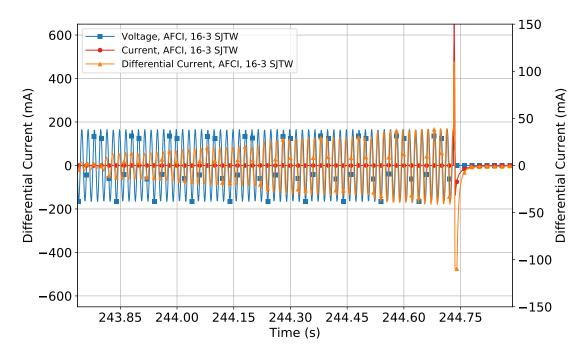
Additionally, there were three cases (two AFCI, one MCCB) where 3-conductor cord could have potentially had a ground-fault failure had the circuit been a GFCI. Note, the ground-fault trip thresholds for the AFCI breakers were higher than for the GFCI breakers. Two of these cases occurred with SJTW cable (Experiment 1 – 16-3 SJTW, MCCB and Experiment 6 – 16-3 SJTW, AFCI) and one with an SVT cable (Experiment 2 – 18-3 SVT, AFCI). Figure 4.10 shows the voltage, current, and differential current for Experiment 6 – 16-3 SJTW with an AFCI breaker. In all three of these cases, there were escalating differential current prior to the magnetic trip as shown in Figure 4.10, as well as peak RMS differential current values over the ground-fault threshold for the GFCIs used. The experiments revealed that it cannot be assumed that because an AFCI or GFCI circuit tripped, that it was a result of an arc-fault or a ground-fault.

Figure 4.10: Experiment 6 – Signal data of a AFCI breaker with 16-3 SJTW cord (Circuit 5) that showed signs of a ground-fault but had an over-current trip.

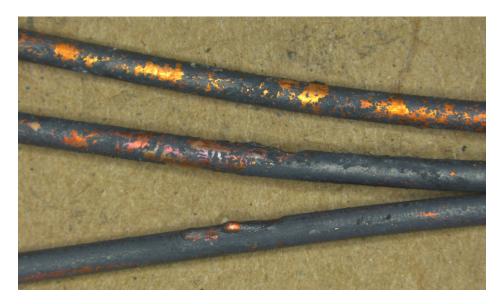
Following each experiment, the remains of each cord were carefully removed from the floor to limit potential damage to the cords to only that which was caused by the fire. Each cord was cleaned to remove large debris. The cords were then photographed using an 8x magnification digital microscope. From these images, beads, notches, and broken strands were able to be clearly identified. The damage to the conductors was consistent with electrical arcing. Figure 5.2 shows an example of a bead and notch that formed in a 12-2 NM-B conductor that had a magnetic trip in Experiment 2.

Figure 5.2: Magnified photograph of the 12-2 NM-B cable on a thermal magnetic circuit breaker following Experiment 2 showing both a bead and a notch on the cable.

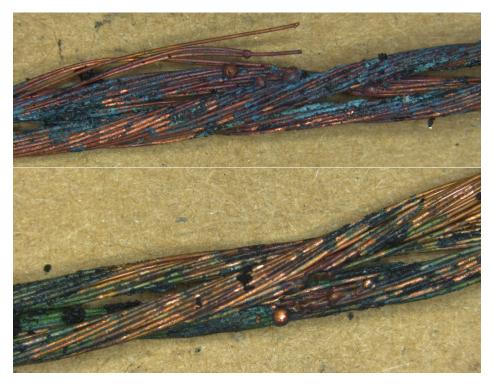
Figure 5.3: Magnified photograph of the 16-3 SJTW cord on a thermal magnetic circuit breaker following Experiment 1 (top) and Experiment 5 (bottom).

Two of the images are from circuits that were considered outliers from the signal analysis (Experiment 1, MCCB and Experiment 6, AFCI). There are no visual cues from any post-experiment images in Figures 5.3–5.5 that would indicate different behavior. Beading and broken strands were not unique to any particular circuit protection. For an overview of the damage to each cord for all of the experiments, see Table D.1 in Appendix D.

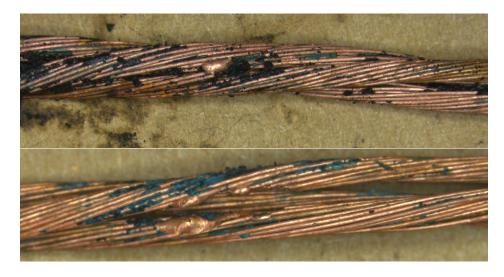
Figure 5.4: Magnified photograph of the 16-3 SJTW cord on an AFCI following Experiment 2 (top) and Experiment 6 (bottom).

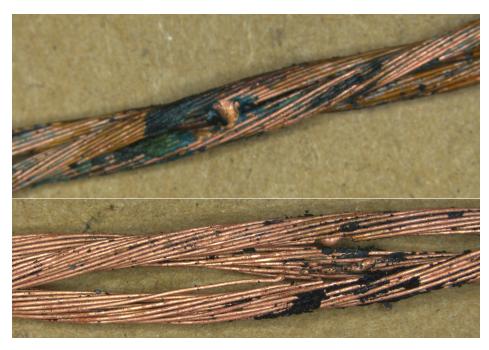
Figure 5.5: Magnified photograph of the 16-3 SJTW cord on a GFCI following Experiment 3 (top) and Experiment 4 (bottom).
