Impact of Flashover Fire Conditions on Exposed Energized Electrical Cords and Cables

Craig Weinschenk Daniel Madrzykowski Paul Courtney*

UL Firefighter Safety Research Institute Columbia, MD 21045

Revised October 2, 2019

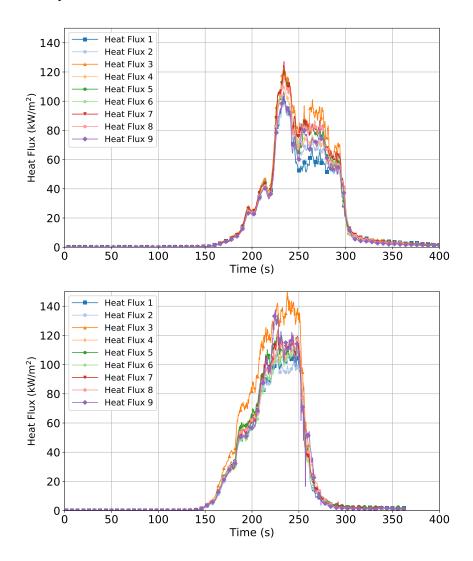
have the minimum and maximum fuel load, respectively. Figure 4.4 shows that while the peak values vary between the experiments (recall heat release data in Figure 4.1) the mean heat flux sits within the uncertainty of measurements.

Figure 4.4: Experiment 5 (top) and Experiment 6 (bottom) – Heat flux time-history at the floor near the vent opening.

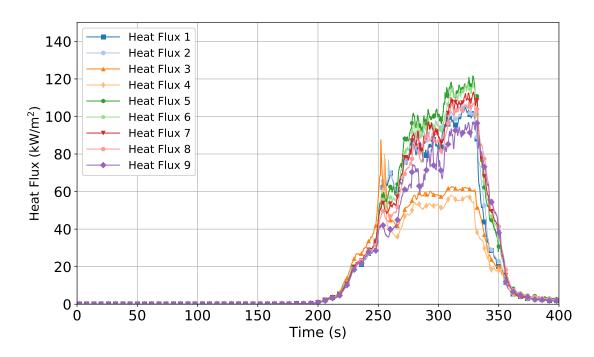
In Experiments 1, 2, and 3, however, there was debris that fell from the ceiling. The debris (Figure 4.5) landed overtop some of the heat flux gauges effectively lowering the heat flux measurement from the gauge. In Experiment 1, heat flux gauges 3 and 4 both had debris land on top of them. Figure 4.6 shows the lower values of gauges 3 and 4 through the time history of the experiment.

Figure 4.6: Experiment 1 – Heat flux time-history at the floor near the vent opening.
